# Technical Memorandum

To: URS Project File 52-00080001.00  
From: Chris Moody  
Date: December, 28, 2000  
Subject: In-water Waste Recovery Activities-  
Bradford Island Landfill

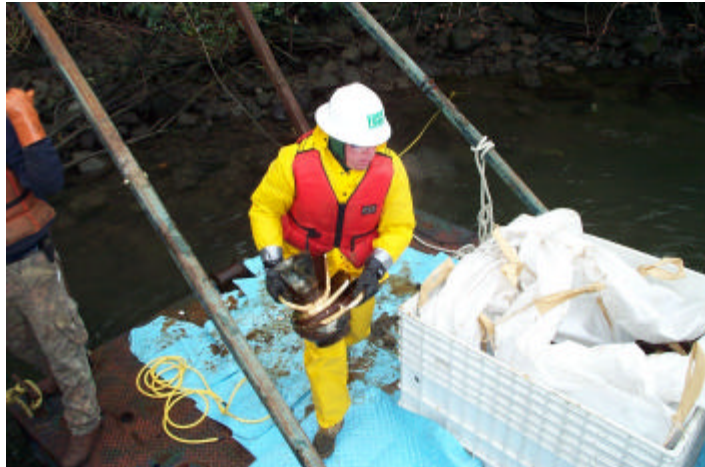
Recovery of a Post Insulator

The post insulators, electrical panels, and lightening arrestors were recovered by having a diver place a cable attached to the winch on the boat around the item. The electrical panels were recovered by having a diver place a “U” bolt through a pre-existing hole on the panels. Once at the surface Foss placed these materials into a 1-yard bulk bag made of tight nylon mesh, and stored these bags on a barge provided by Advanced American located next to the work boat.

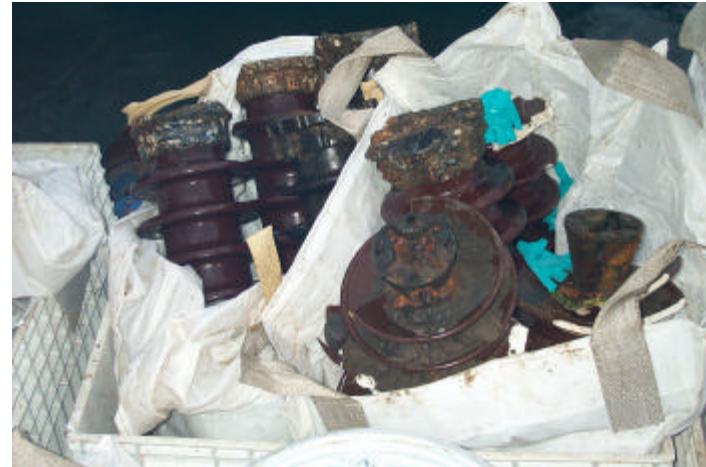
Recovered Lightning Arrestors (on the left) and  
Post Insulators (on the right)

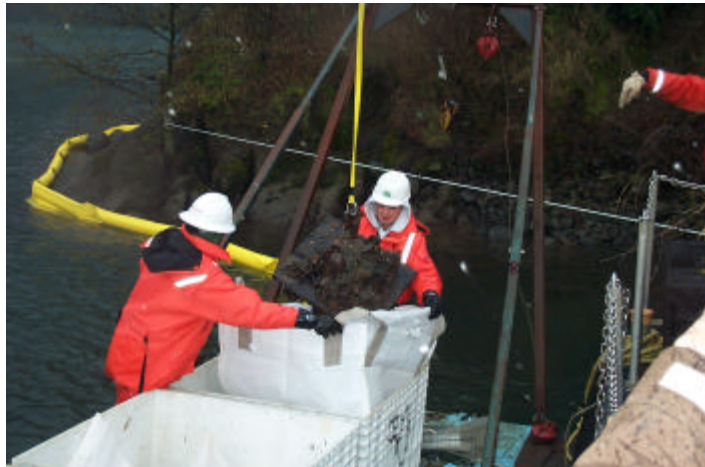
Recovering an Electrical Panel

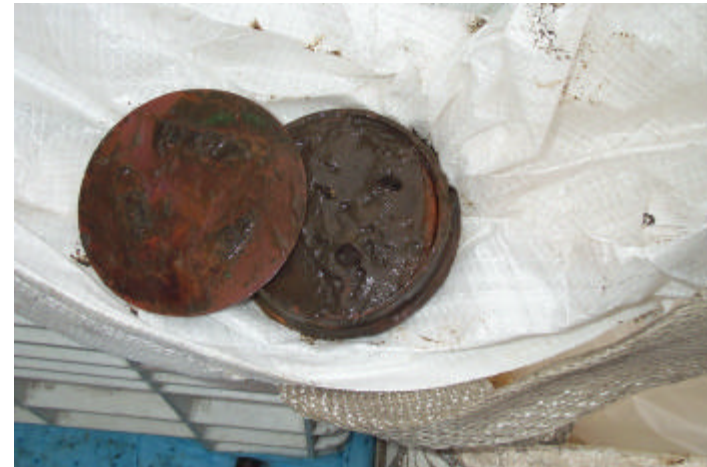
The disk and the back of the panel had acted as a sediment trap, therefore these samples consisted mostly of fine sands and silt sized particles. The other two samples that were collected from the riverbed consisted mostly of medium sized sands, since the sampling method could not recover the finer grained material from these areas.

Sediment Located in Disk From an Arrestor (sampled)
